UDEEC Model: Wall Delamination

Wall Delamination: Effectiveness of Through Stones

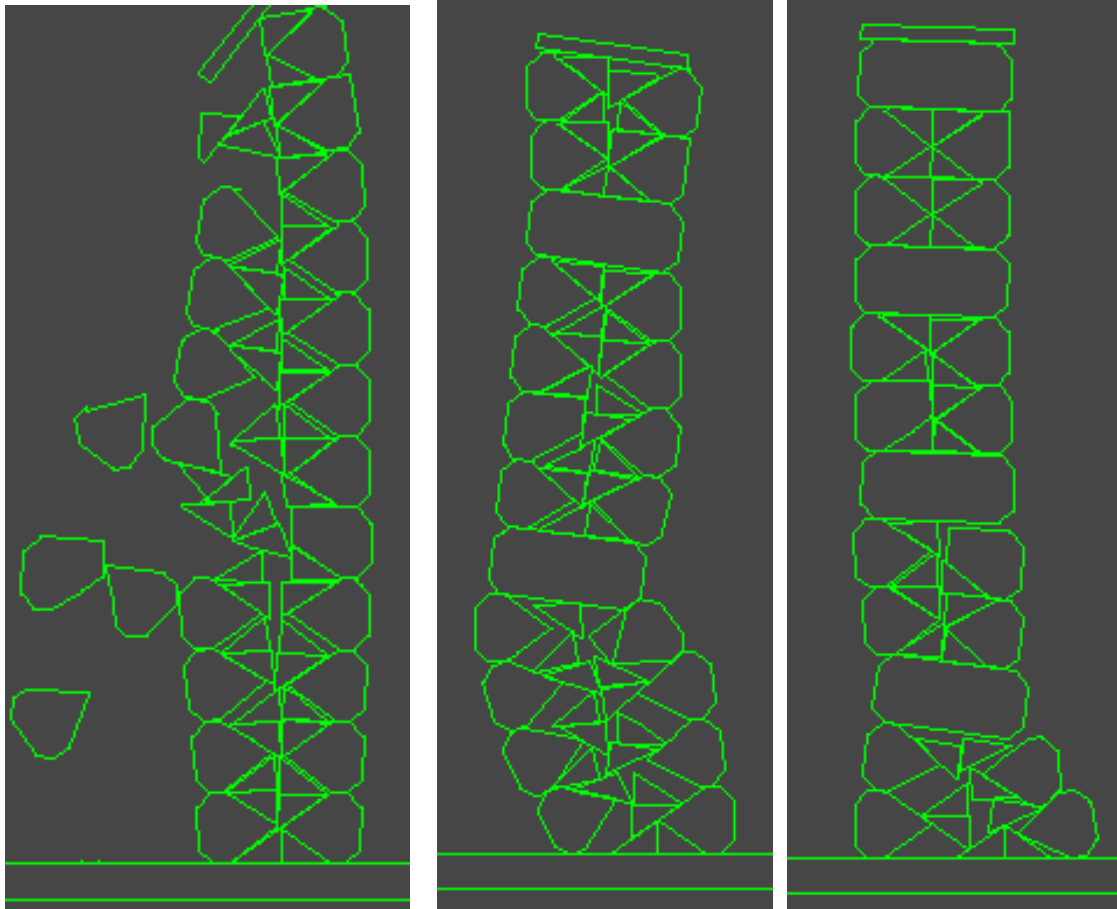
The failure of the model with no through-stones did not only fail at a significantly lower loading acceleration, but it also failed in a catastrophic manner, dissipating only limited energy during the failure process. The models with through-stones deformed significantly before fully failing.
